**Docket No. 217 – Development and Management Plan Inspection**

Northeast Utilities Service Company Certificate of Environmental Compatibility and Public Need for the construction of a 345-kV electric transmission line and reconstruction of an existing 115-kV electric transmission line between Connecticut Light and Power Company's Plumtree Substation in Bethel, through the towns of Redding, Weston, and Wilton, and to the Norwalk Substation in Norwalk, Connecticut.

**Date:** April 26- 27, 2006

**Location:** Transition Stations: Hoyts Hill, Archers Lane, Norwalk Junction

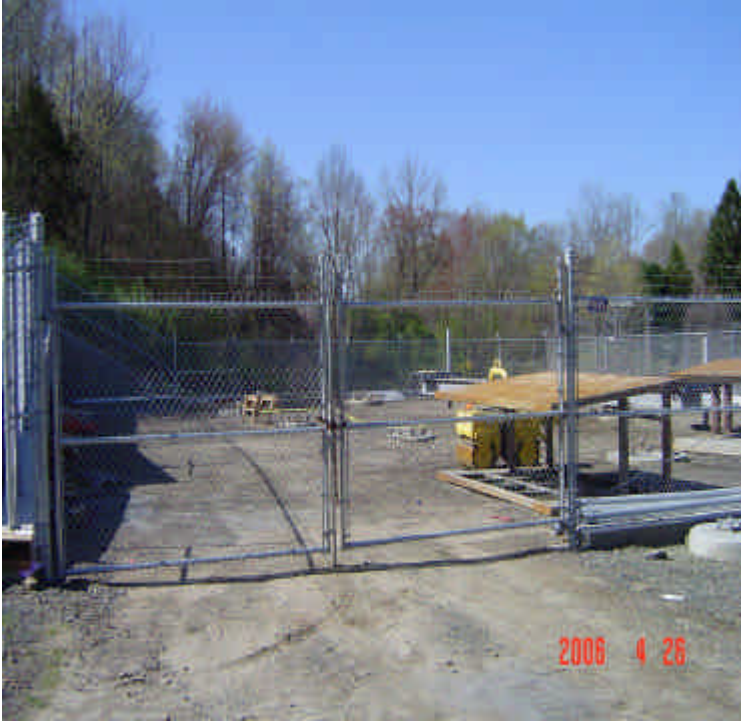
**Hoyts Hill Transition Station: Photo on the left shows the transition station pad where the active work was not occurring. Photo on the right shows the southern slope where some erosive washouts remain. 4/26/06**

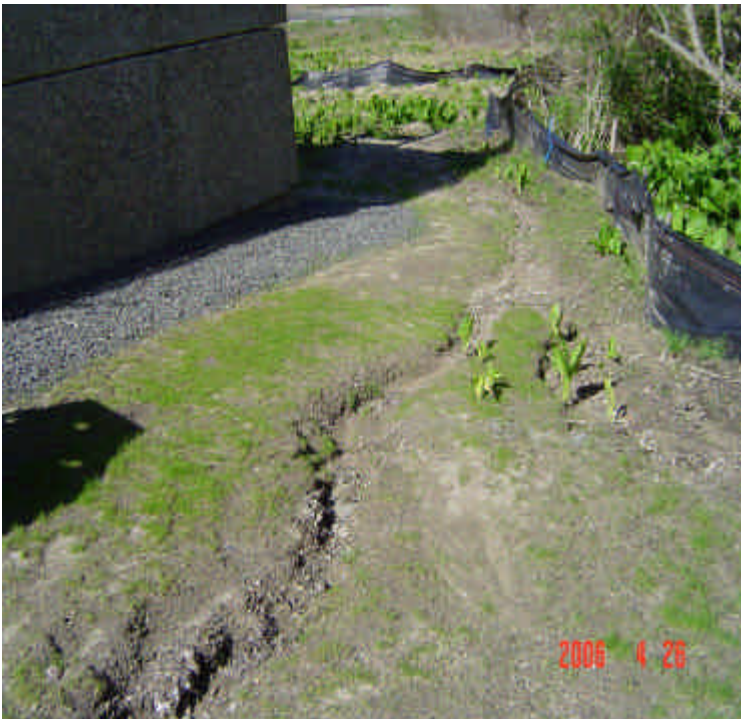
**Photo on the left shows the remaining large gully on the southern slope. Photo on the right shows the recently restored northern slope with grass growth beginning. 4/26/06.**

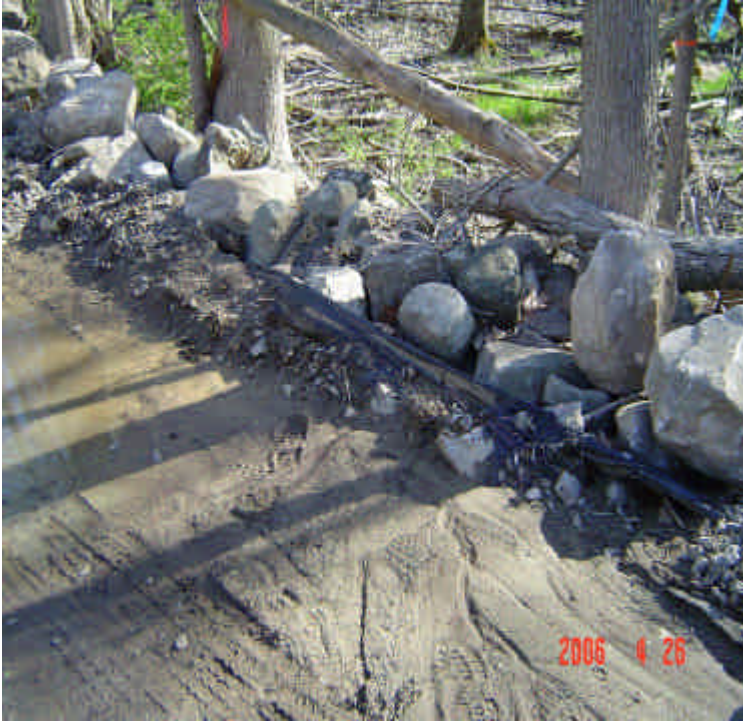
Archers Lane: Photo on the left shows where some sediment was moving from the access road through the stone wall. Consider restoring silt fence here. Photo on the right shows the work on the station pad with the recently installed tower in the background. 4/26/06.

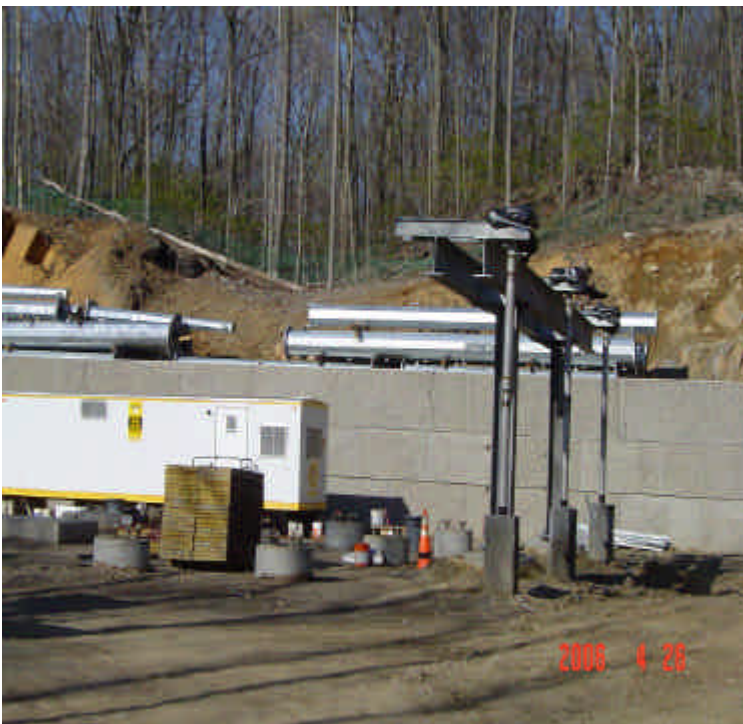
Photo on the left shows a further view of the pad. Photo on the right shows the 1<sup>st</sup> wetland crossing near the station. Further sediment accumulation has occurred and needs to be removed. 4/26/06.

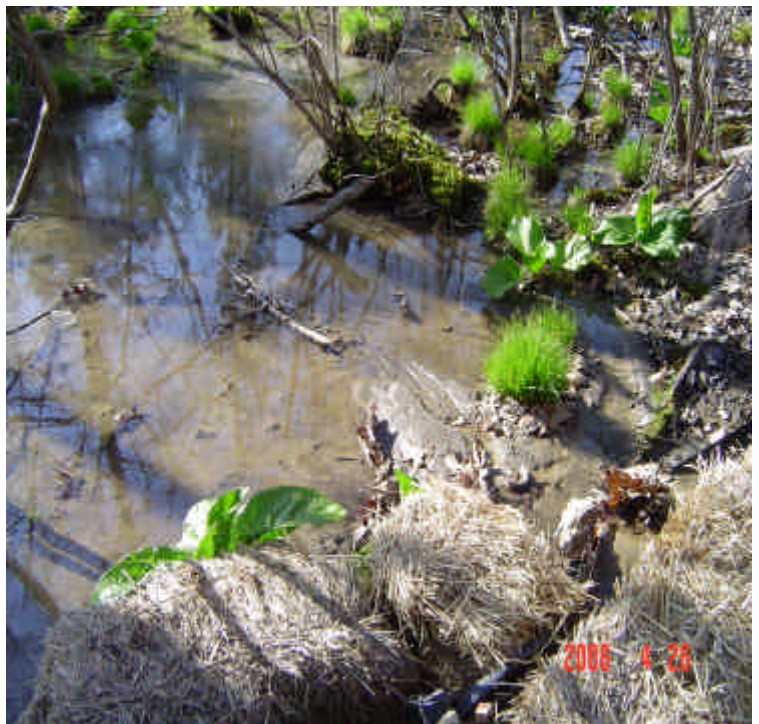
<p>- <b>Archers Lane</b>: Sediment removal efforts are still needed at the 1<sup>st</sup> wetland as accumulation increased with recent rains. 4/26/06.</p> <p>-Restoration efforts will be necessary along the disturbed slopes of the access road. 4/26/06</p>	<p>Any easily accessible deposits of sediment need to continue to be removed. Fine layers of silt can remain. 4/6-4/26/06</p> <p>-Determine whether 345kV or AL contractors should perform restoration. 4/26/06</p>	<p>- Still needs attention</p> <p>- Needs attention</p>

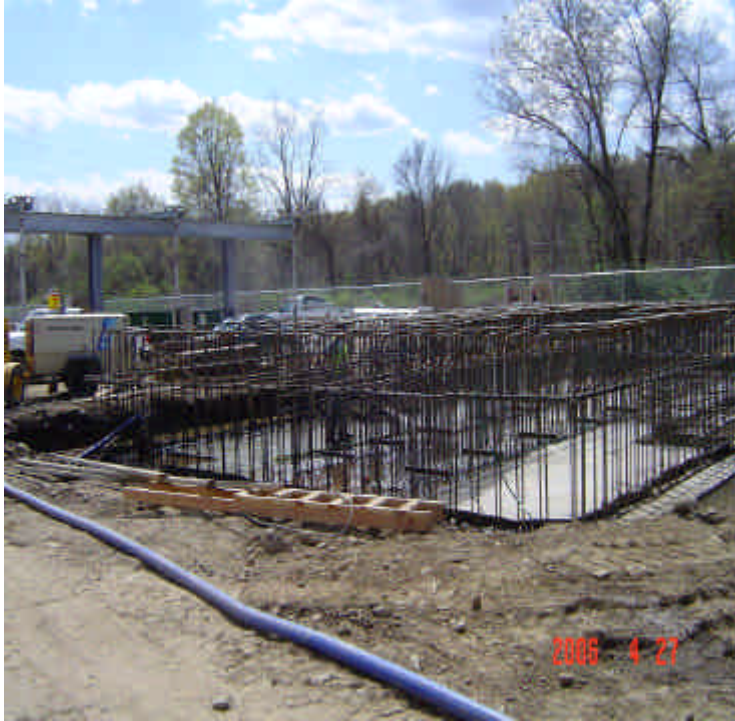
Areas of Inspection	Observation	Recommended Action	Corrected Actions
Norwalk Junction	<p>remain installed across the swale. 4/6-4/26/06</p> <p>-Dewatering was necessary due to the flooding within the station yard. Footings had to be washed off, creating turbid water. 4/26/06.</p>	<p>-This was being sent to the swale and eventually the wetland area at the headwall. More controls were needed for filtration. 4/26/06.</p>	<p>-N/A</p> <p>- Needs attention</p>
Blasting	- All blasting is complete at this time. 4/26/06	- None at this time.	-N/A
Soils	<p>- Soil remains at the Archers Lane site from excavations but it is well contained. 4/26/06</p> <p>- A number of soil stockpiles remain at Norwalk Junction as excavation continues. The large stockpiles near the swale now have silt fence installed. 4/26/06.</p>	<p>- None at this time 4/26/06.</p> <p>- Stockpiles remain contained as long as perimeter silt fence is restored. See erosion control section. 4/26/06.</p>	<p>-N/A</p> <p>-N/A</p>

**Norwalk Junction:** Photo on the left shows the foundation work which was flooded by the recent rains and the river. Sediment had to be washed off and removed. Photo on the right shows where the river flooded, leaving leaves along the perimeter fence. 4/26/06.

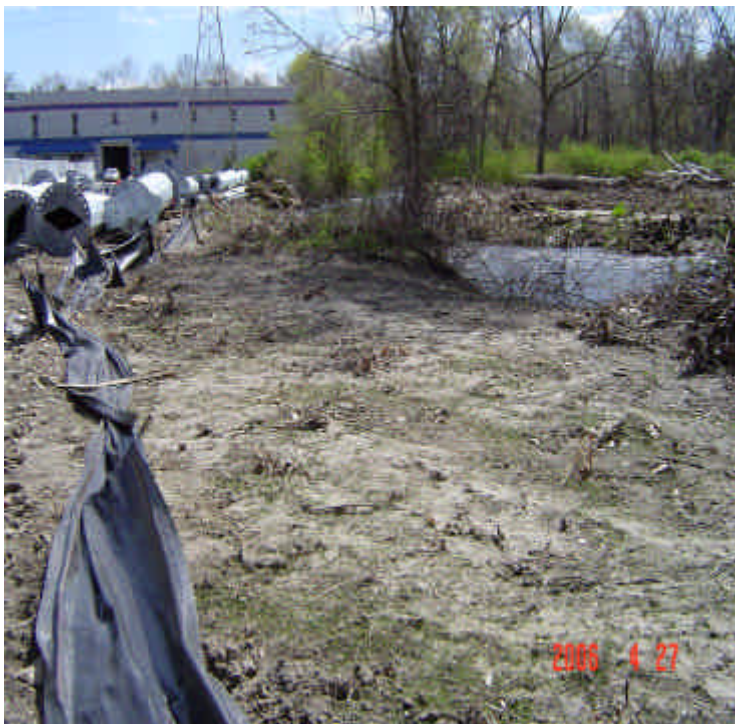
Areas of Inspection	Observation	Recommended Action	Corrected Actions
Erosion and Sediment Controls continued	<ul style="list-style-type: none"> <li>- Silt fence is also down along the access drive and some minor sedimentation is occurring. 4/26/06</li> <li>- <b>Norwalk Junction:</b> The recent Norwalk River flood scattered the haybales along the perimeter fence 4/26/06.</li> <li>- Flooding also took out the perimeter silt fence. 4/26/06.</li> </ul>	<ul style="list-style-type: none"> <li>- Consider restoring silt fence here. 4/26/06</li> <li>- The haybales should be repaired as an additional control but are not as essential as the silt fence 4/26/06.</li> <li>- Repair and reinforce silt fence along the river 4/26/06.</li> </ul>	<ul style="list-style-type: none"> <li>- Needs attention if feasible</li> <li>- Needs attention if feasible</li> <li>- Needs attention</li> </ul>
	<ul style="list-style-type: none"> <li>- The old culvert near the silt fence and the river was observed. It still shows evidence of occasional flow, including sediment from the disturbed soil at the site. 3/15-4/26/06.</li> <li>- The wetland area outside the silt fence adjacent to the river contained pooled turbid water partly due to the dewatering and cleaning up on site 4/26/06.</li> <li>- Sediment from small washouts along the slope of the swale introduces more potential for turbidity. 2/16-4/26/06.</li> <li>- Dewatering was sending turbid water to the swale. 4/26/06</li> </ul>	<ul style="list-style-type: none"> <li>- The culvert should be removed/or the connection cut, completely if feasible 4/12-4/26/06.</li> <li>- This area receives direct runoff from the site through the swale making water quality important. 1/19-4/26/06 Silt fence should be maintained in this location. 4/26/06.</li> <li>- The slumping or washouts on the slope should be repaired with further seeding or stabilization. 3/8-4/26/06.</li> <li>- More controls were requested to improve water clarity here. 4/26/06</li> </ul>	<ul style="list-style-type: none"> <li>- Needs attention</li> <li>- Needs attention</li> <li>- Needs attention</li> </ul>

Photo on the left shows the silt fence which was washed out by the flooded river. Photo on the right shows where turbid water was pooling in the wetland as a result of dewatering the sediment from the foundations on site. 4/26/06.

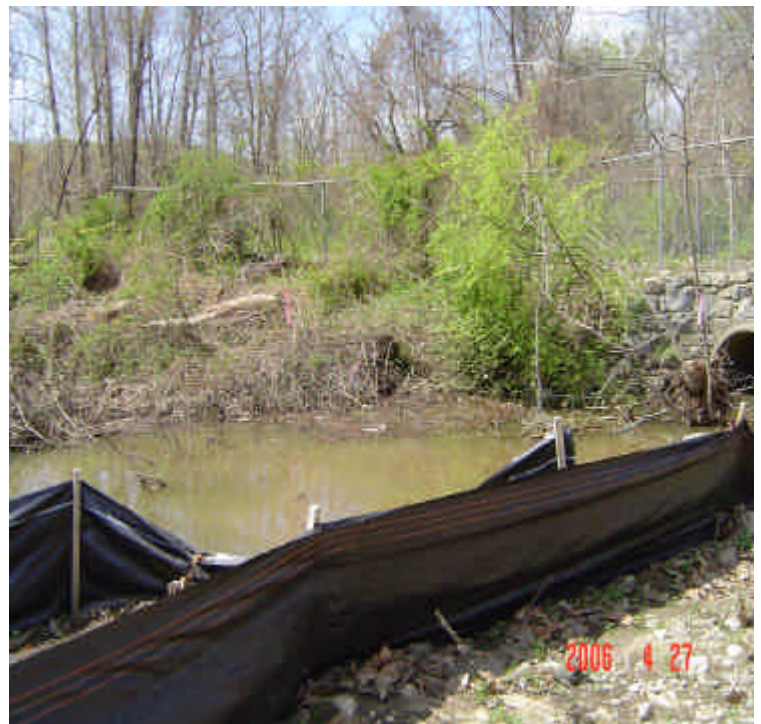
Areas of Inspection	Observation	Recommended Action	Corrected Actions
	<p>walls. Efforts need to continue removing deposited sediment from the 1<sup>st</sup> wetland crossing. 2/16-4/26/06.</p> <p><b>- Norwalk Junction:</b> The outlet of the drainage swale is at the headwall of the wetland area. Turbid water is present here in the wetlands but has not had a significant impact on the river. 12/30-4/26/06.</p> <p>-Recent Norwalk River flooding caused problems on site but the water was running clear at the time of inspection. 4/26/06</p>	<p>significant buildups. 2/16-4/26/06.</p> <p>-See Erosion Control Section for more details. Reduce turbidity by controlling its source-disturbed surfaces on site. 12/30-4/26/06.</p> <p>- None at this time 4/26/06</p>	- N/A
State species of concern, threatened and endangered species	- No species of concern are located in these areas of construction.	- N/A	-N/A
Vegetative clearing limits (including trees to save or danger trees noted)	<p><b>-Hoyts Hill:</b> The southern slope still needs to be revegetated in the spring as necessary. Grass growth was occurring along the restored northern slope. 4/26/06.</p> <p><b>- Archers Lane:</b> no additional clearing was noted here. 4/26/06.</p> <p><b>- Norwalk Junction:</b> -Additional clearing associated with corridors in from the adjacent new ROW was complete. 4/19/06.</p>	<p>- Repairs to washouts on the south side will be needed. Determine whether additional seed will be necessary. 4/12-4/26/06.</p> <p>-None at this time. 2/23/06-4/26/06.</p> <p>- Restore areas along the perimeter of the station pad as feasible. 4/26/06.</p> <p>See Overhead Report for more details. 4/26/06</p>	<p>-The northern slope is stabilized with grass growing</p> <p>-N/A.</p> <p>- N/A until work is completed.</p> <p>-N/A</p>
